Infrared Inspection of Electrical / Mechanical Equipment

3/7/2010

**ACME
COMPANY**

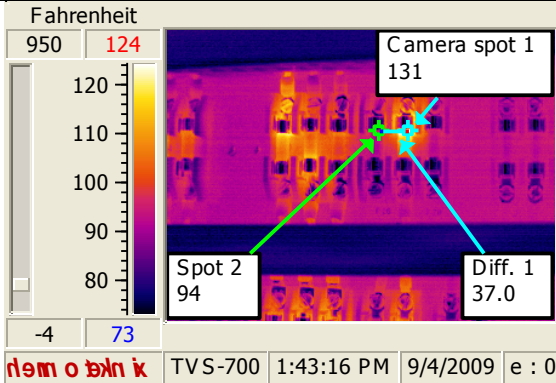
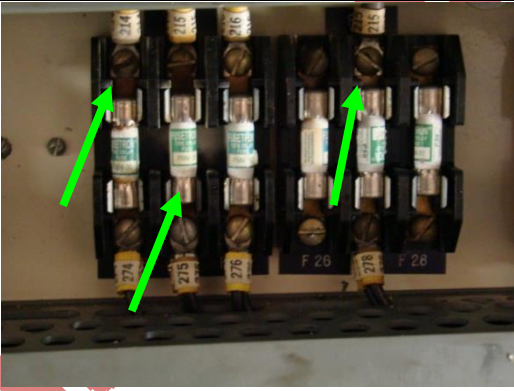
Inspection Date	9/4/2009	Image Information	9
Inspection Time	01:43 PM	Section	B
Background Temperature	80.6°F	Equipment	Bl
		Thermographer	Ray Burleson Level I&II Certified

Item	Value	Measurement
Camera spot 1	Value	131.2°F
Spot 2	Value	94.2°F
Diff. 1	Difference	37.0°F

The IR Thermograph indicates damaged fuse holders on Fuse 215 line side, fuse 275 load side, and fuse 214 line side.

Shut off power, inspect, and replace fuse holders.

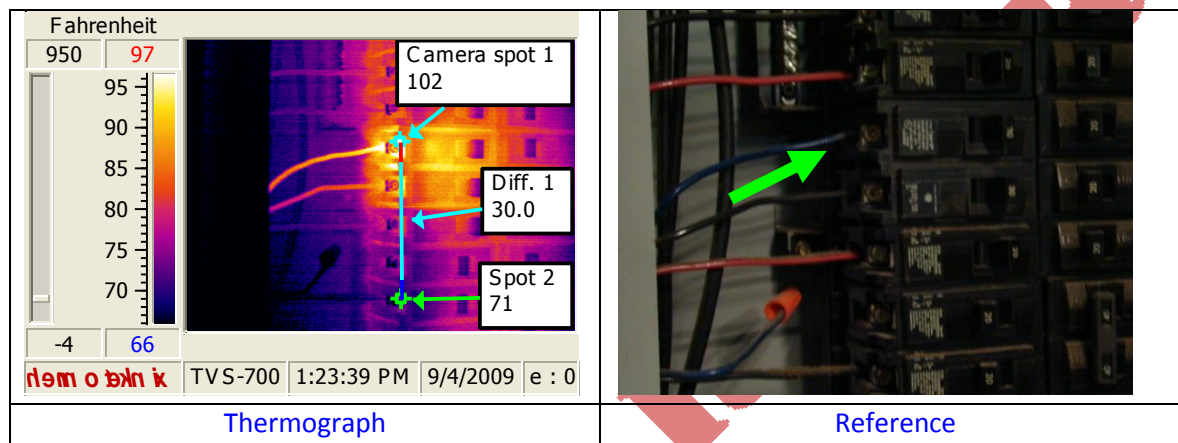
Inspection Date	9/4/2009	Image Information	99040006
Inspection Time	01:23 PM	Section	Switch Board SWD Section 3
Background Temperature	82.4°F	Equipment	Panel A-1
		Thermographer	Ray Burleson Level I&II Certified

Item	Value	Measurement
Camera spot 1	Value	101.5°F
Spot 2	Value	71.5°F
Diff. 1	Difference	30.0°F

The IR Thermograph indicates a connection problem on breaker #17. Shut off power, inspect, clean, strip, and redo connection.
